# IN-SERVICE PERFORMANCE AND COSTS OF METHODS TO CONTROL URBAN RAIL SYSTEM NOISE

## SECOND TEST SERIES REPORT

INTERIM REPORT

U.S. DEPARTMENT OF TRANSPORTATION  
URBAN MASS TRANSPORTATION ADMINISTRATION  
Office of Technology Development and Deployment  
Office of Rail and Construction Technology  
Washington DC 20590

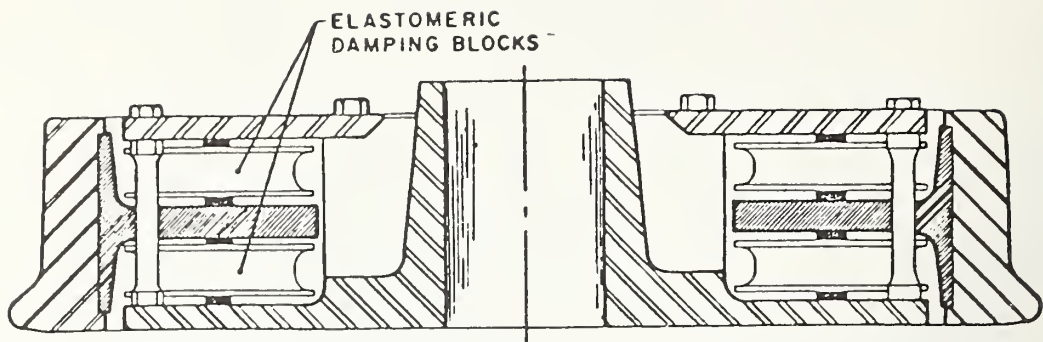
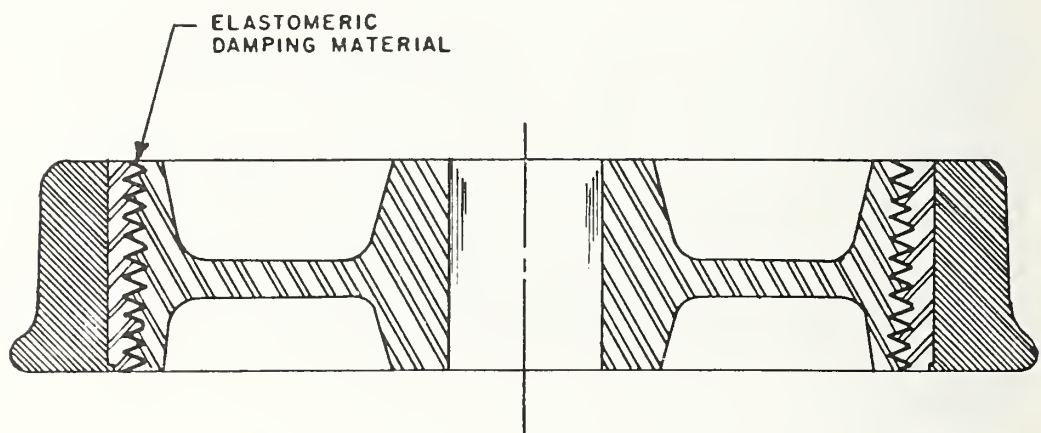
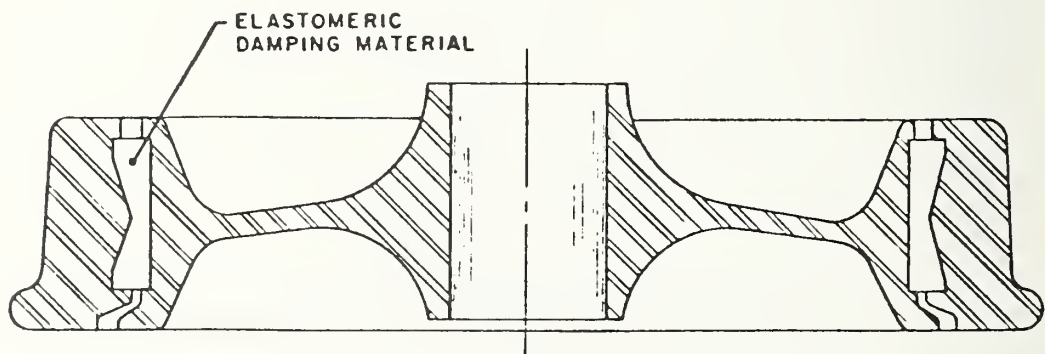
a. SAB RESILIENT WHEEL

b. ACOUSTA FLEX RESILIENT WHEEL

c. PENN CUSHION (BOCHUM) RESILIENT WHEEL

FIGURE 1-1. CROSS SECTION OF RESILIENT WHEELS

The Acousta Flex wheels were removed after a bonding failure occurred between the rim and the elastomeric material on one of the wheels, apparently due to incomplete bonding during manufacturing. One set of the Penn Bochum wheels

experienced damage to the rubber blocks after a dynamic brake failure required the exclusive use of the mechanical, tread brake system. Initial imperfections of two blocks, not detected by the manufacturer's quality control system, were increased due to the combination of the resulting high wheel temperatures and the in-service compresssion stresses. The SAB wheels were removed from the program after the wheels on one axle suffered severe damage from overheating caused by application of the hand brake during revenue service.

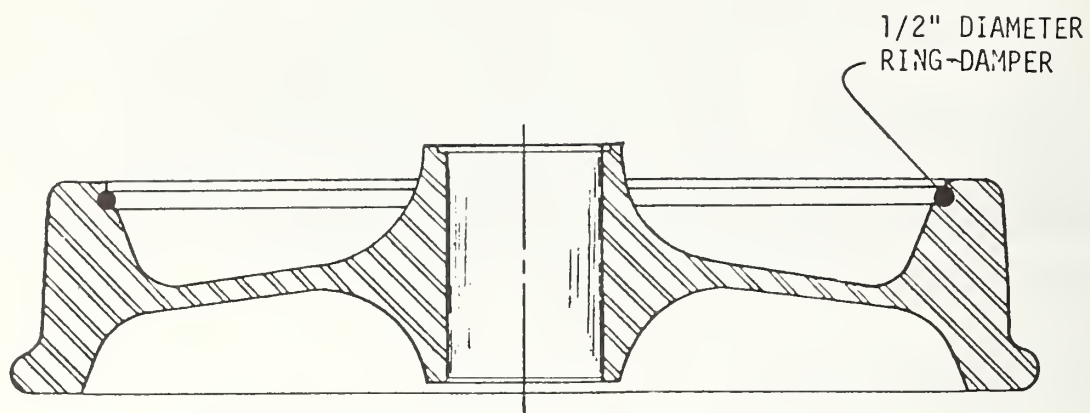
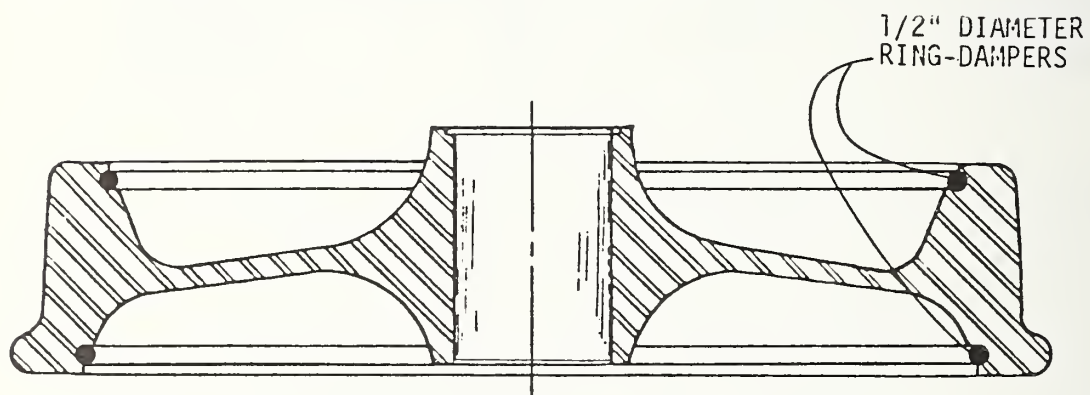
a. RING-DAMPER ON FIELD SIDE

b. RING-DAMPERS ON FIELD AND FLANGE SIDES

FIGURE 1-2. CROSS SECTION OF RING-DAMPED WHEELS

As a part of the second series of tests, three sets of ring-damped wheels were added to the program. As shown in Figure 1-2, ring-damped wheels consist of a mild steel ring inserted in a groove cut into the inside diameter of the wheel tread. The groove may be cut on either the field side or the flange side of the tread. Most of the tests with ring-damped wheels were performed with a 2-car set of wheels grooved on the field side. For the Phase VII tests, a series of wayside wheel squeal tests was performed with a 1-car train having wheels grooved for ring-dampers on both sides. The purpose of these tests was to compare the effectiveness of ring-dampers (on the field side, the flange side, and on both sides) in reducing wheel squeal.

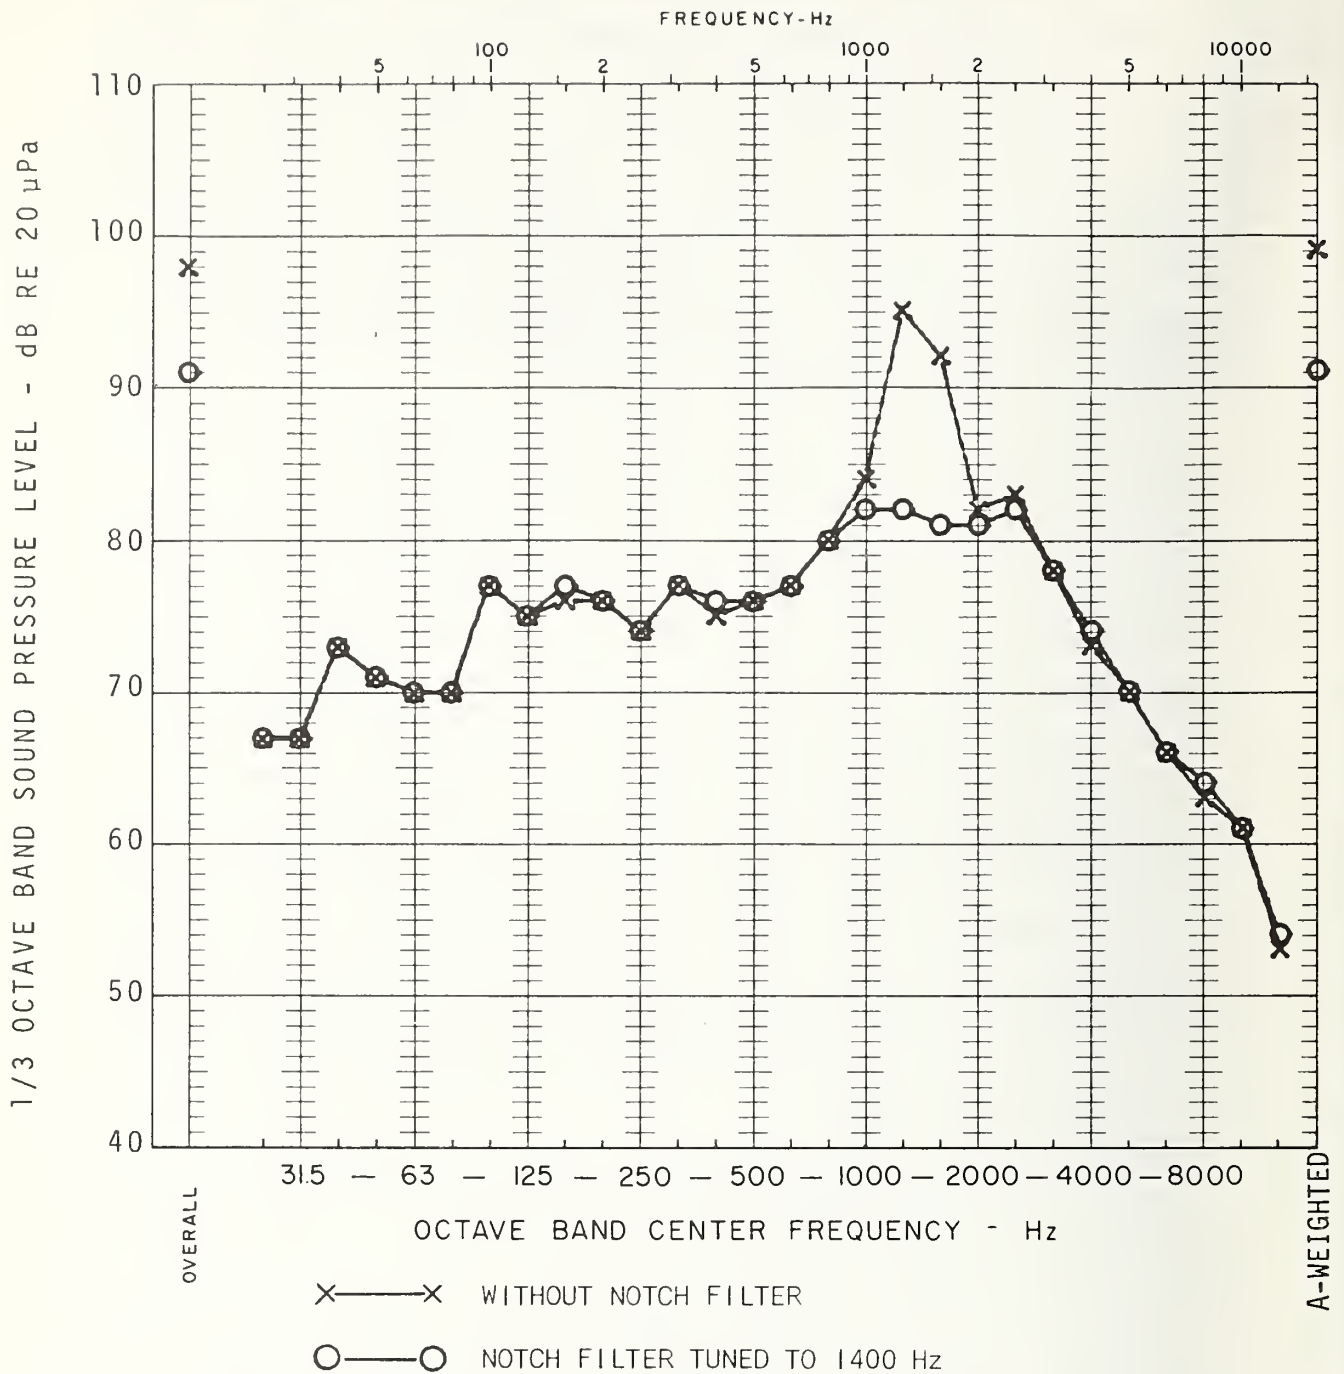
FIGURE 3-1. PROPULSION EQUIPMENT NOISE ANALYZED WITH AND WITHOUT NOTCH FILTER - 7.5 M FROM TRACK CENTERLINE - CARS 607/644  
EQUIVALENT TRAIN SPEED = 110 KM/HR

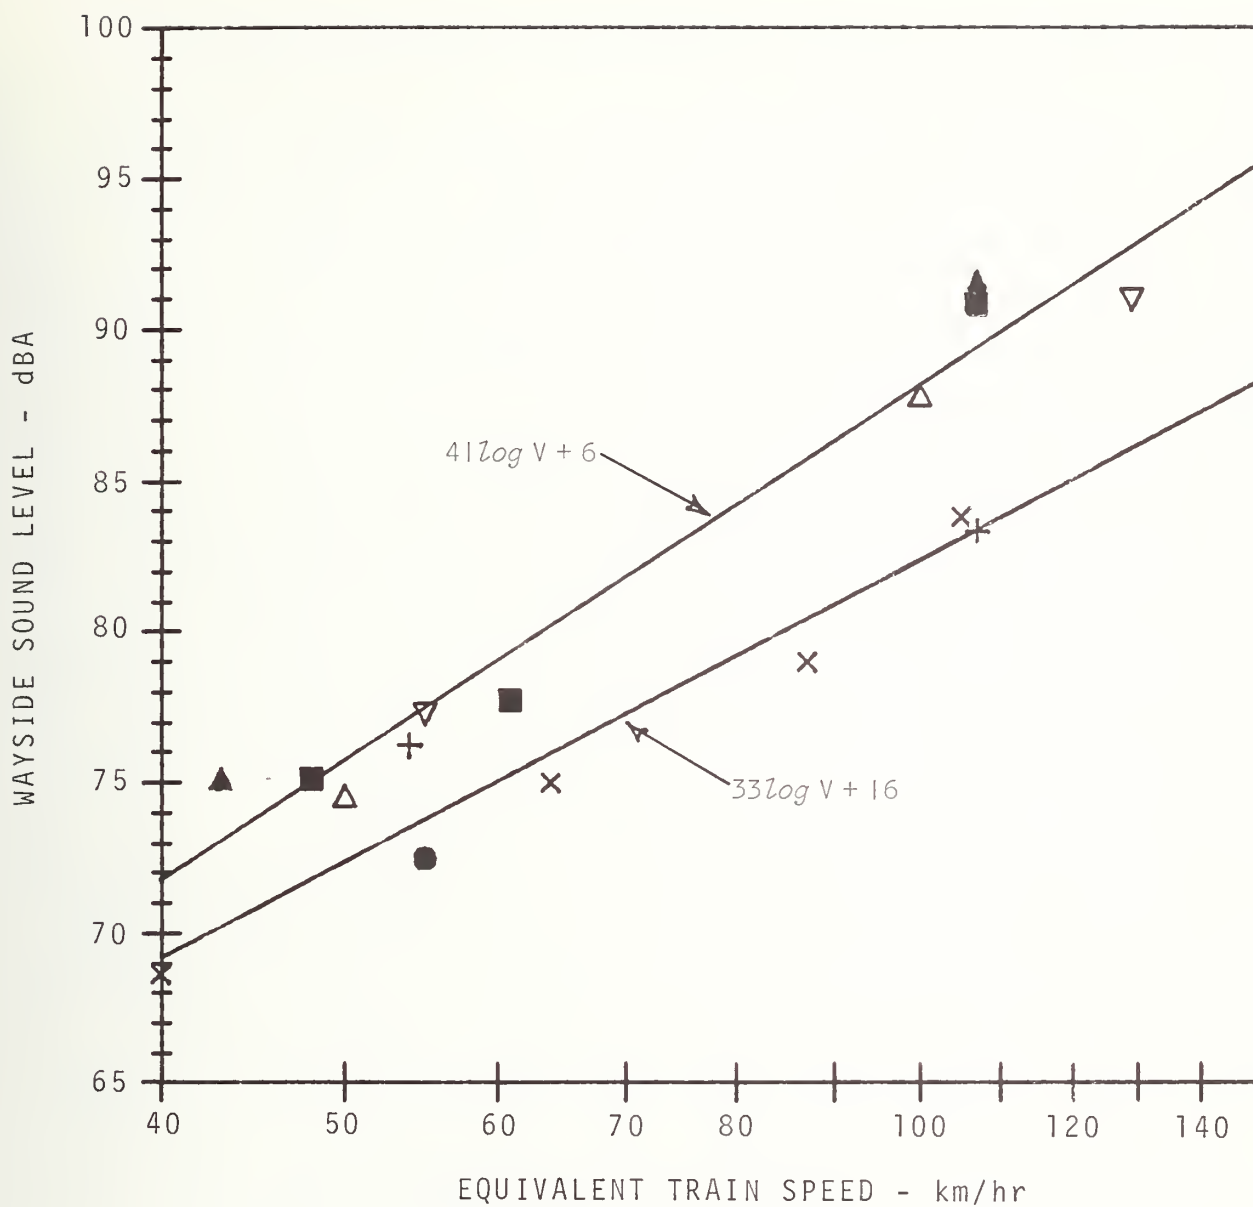
- △ CAR 613
- ▽ CAR 623
- ▲ CARS 613/623
- CARS 607/644

Figure 3-2 presents the wayside noise levels as a function of speed and distinctly shows the difference in noise generation characteristics for the two types of cars. The married pair cars (755/756) generated wayside levels approximately 3 to 5 dBA lower than for the single cars. Note that the data indicate that for the married pair cars, the wayside noise is proportional to  $V^{3.3}$  but for the single cars is proportional to  $V^{4.1}$ . The data also indicate that operating two cars typically increases the level

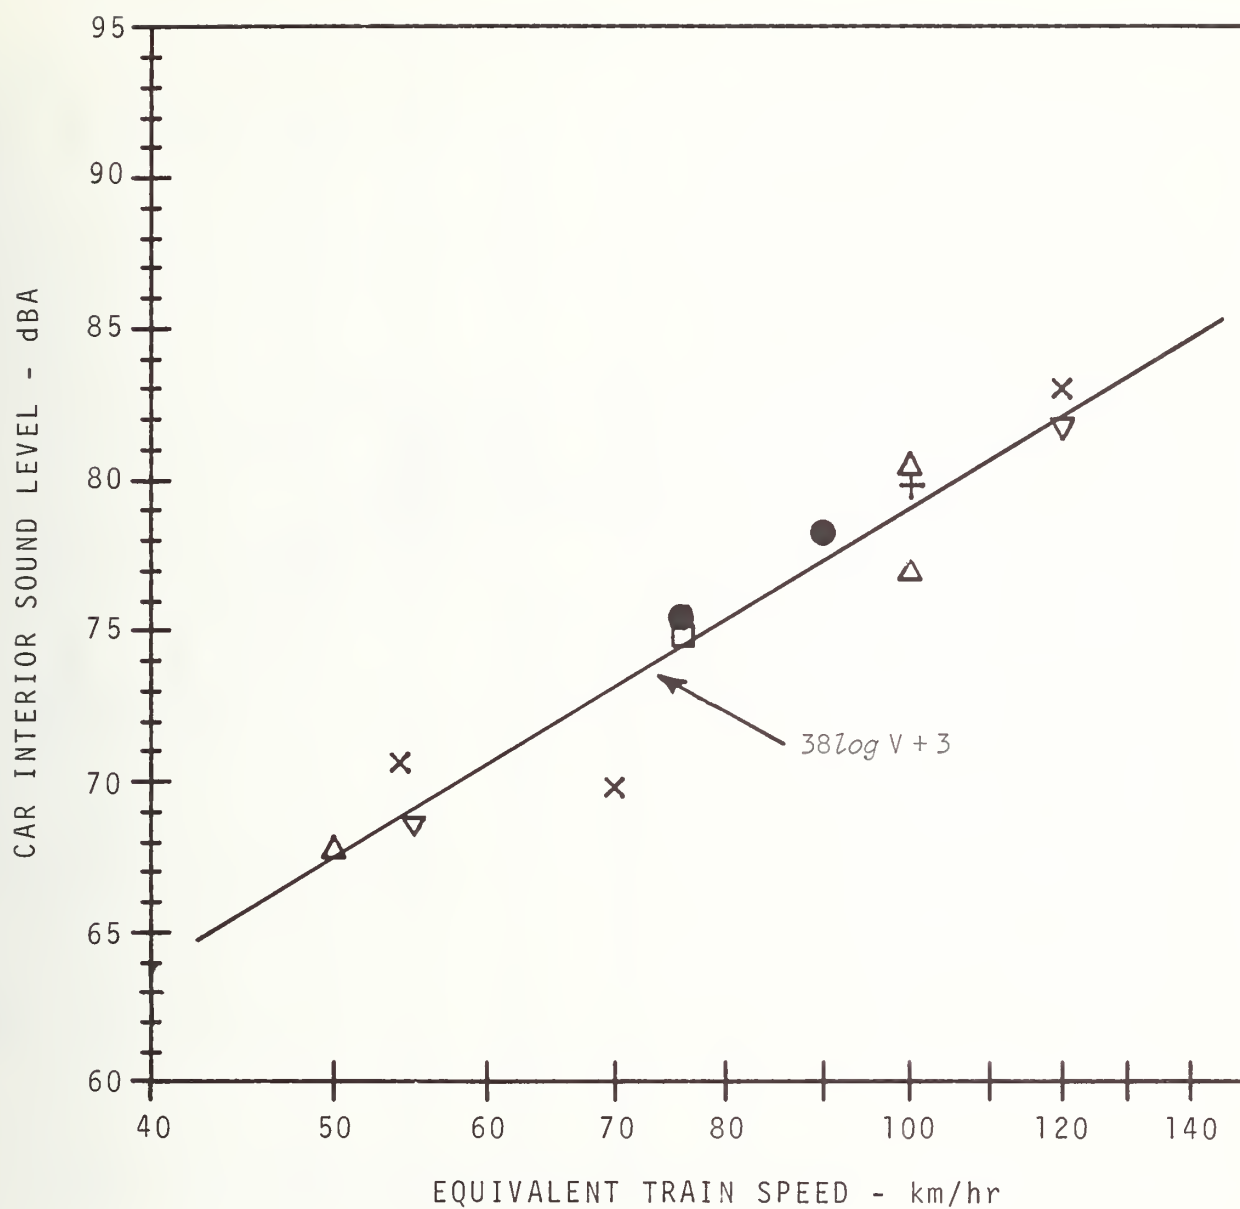
FIGURE 3-3. LEVELS OF PROPULSION EQUIPMENT NOISE AS A FUNCTION OF SPEED - CAR INTERIOR [PURE TONE COMPONENTS REMOVED]

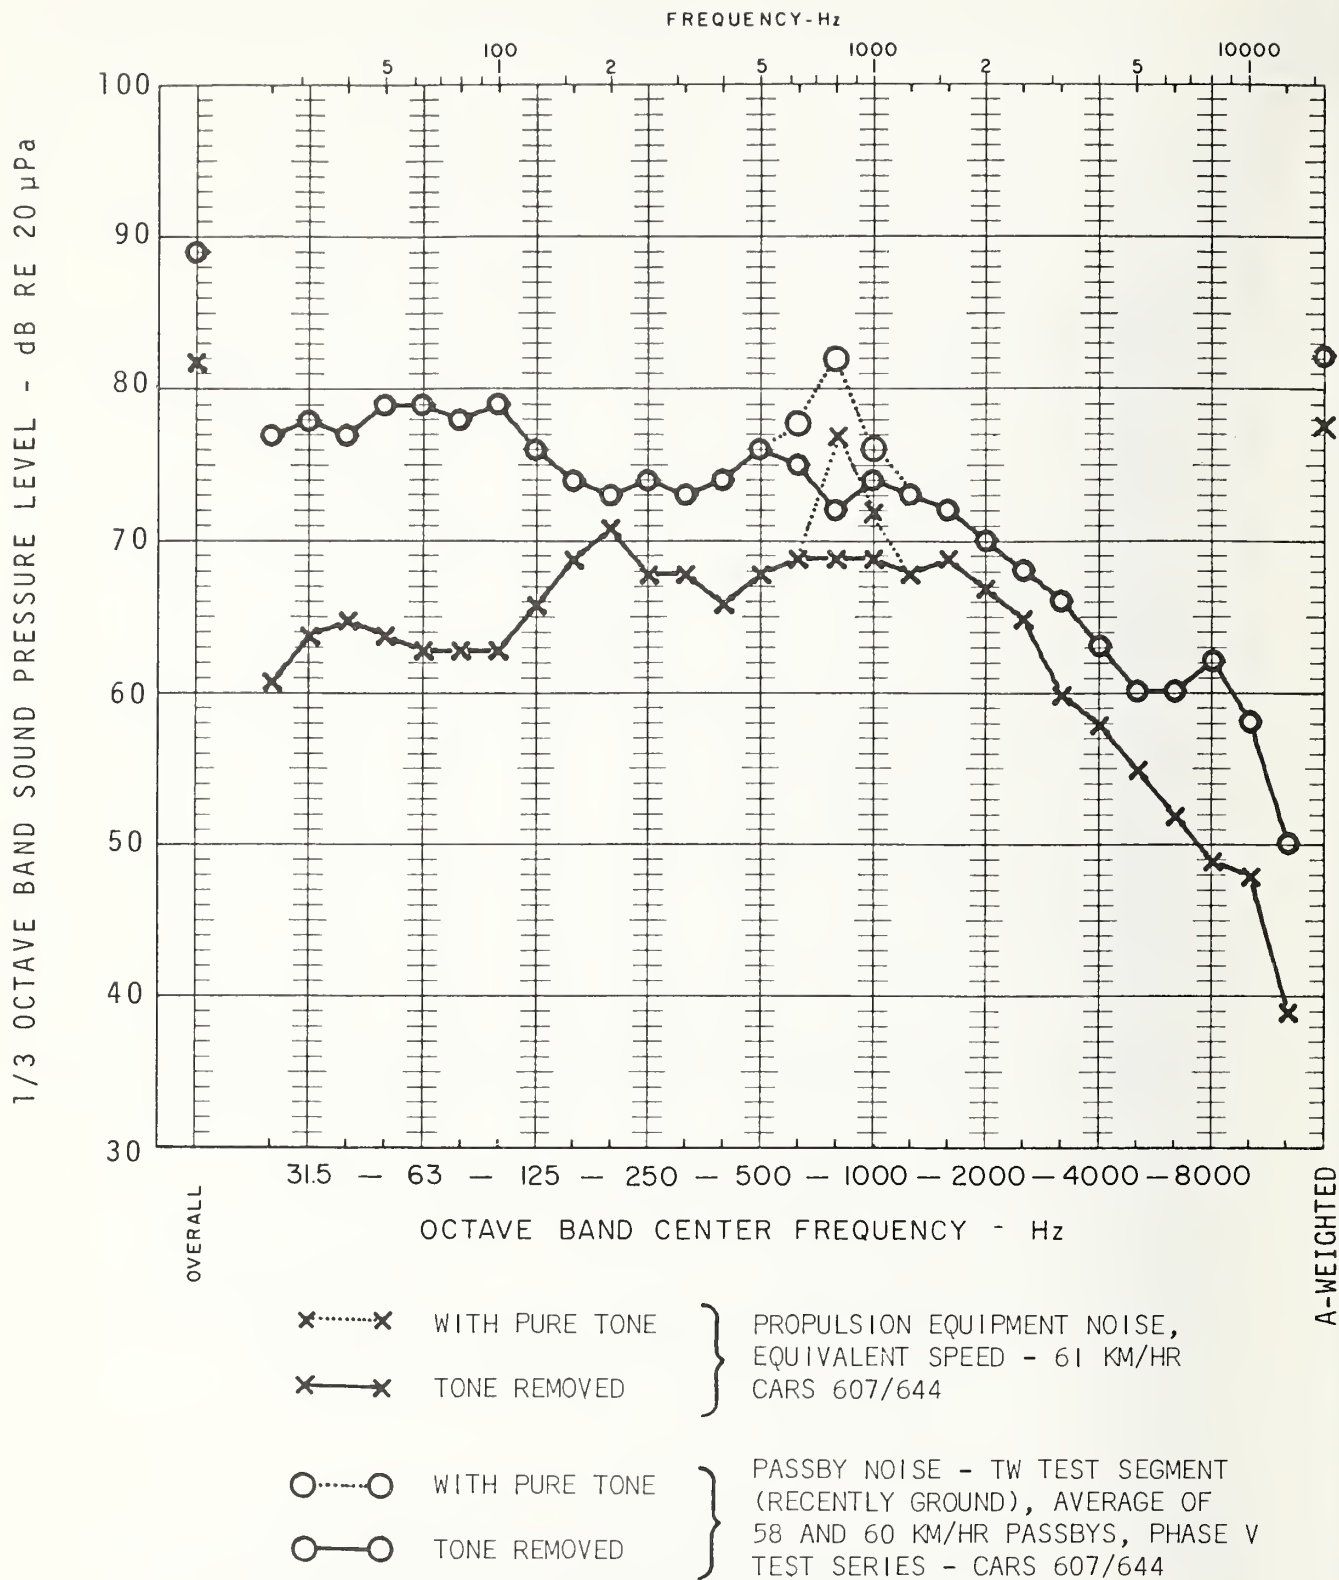
FIGURE 3-4. COMPARISON OF SPECTRA OF PROPULSION EQUIPMENT NOISE AND PASSBY NOISE - 7.5 m FROM TRACK CENTERLINE

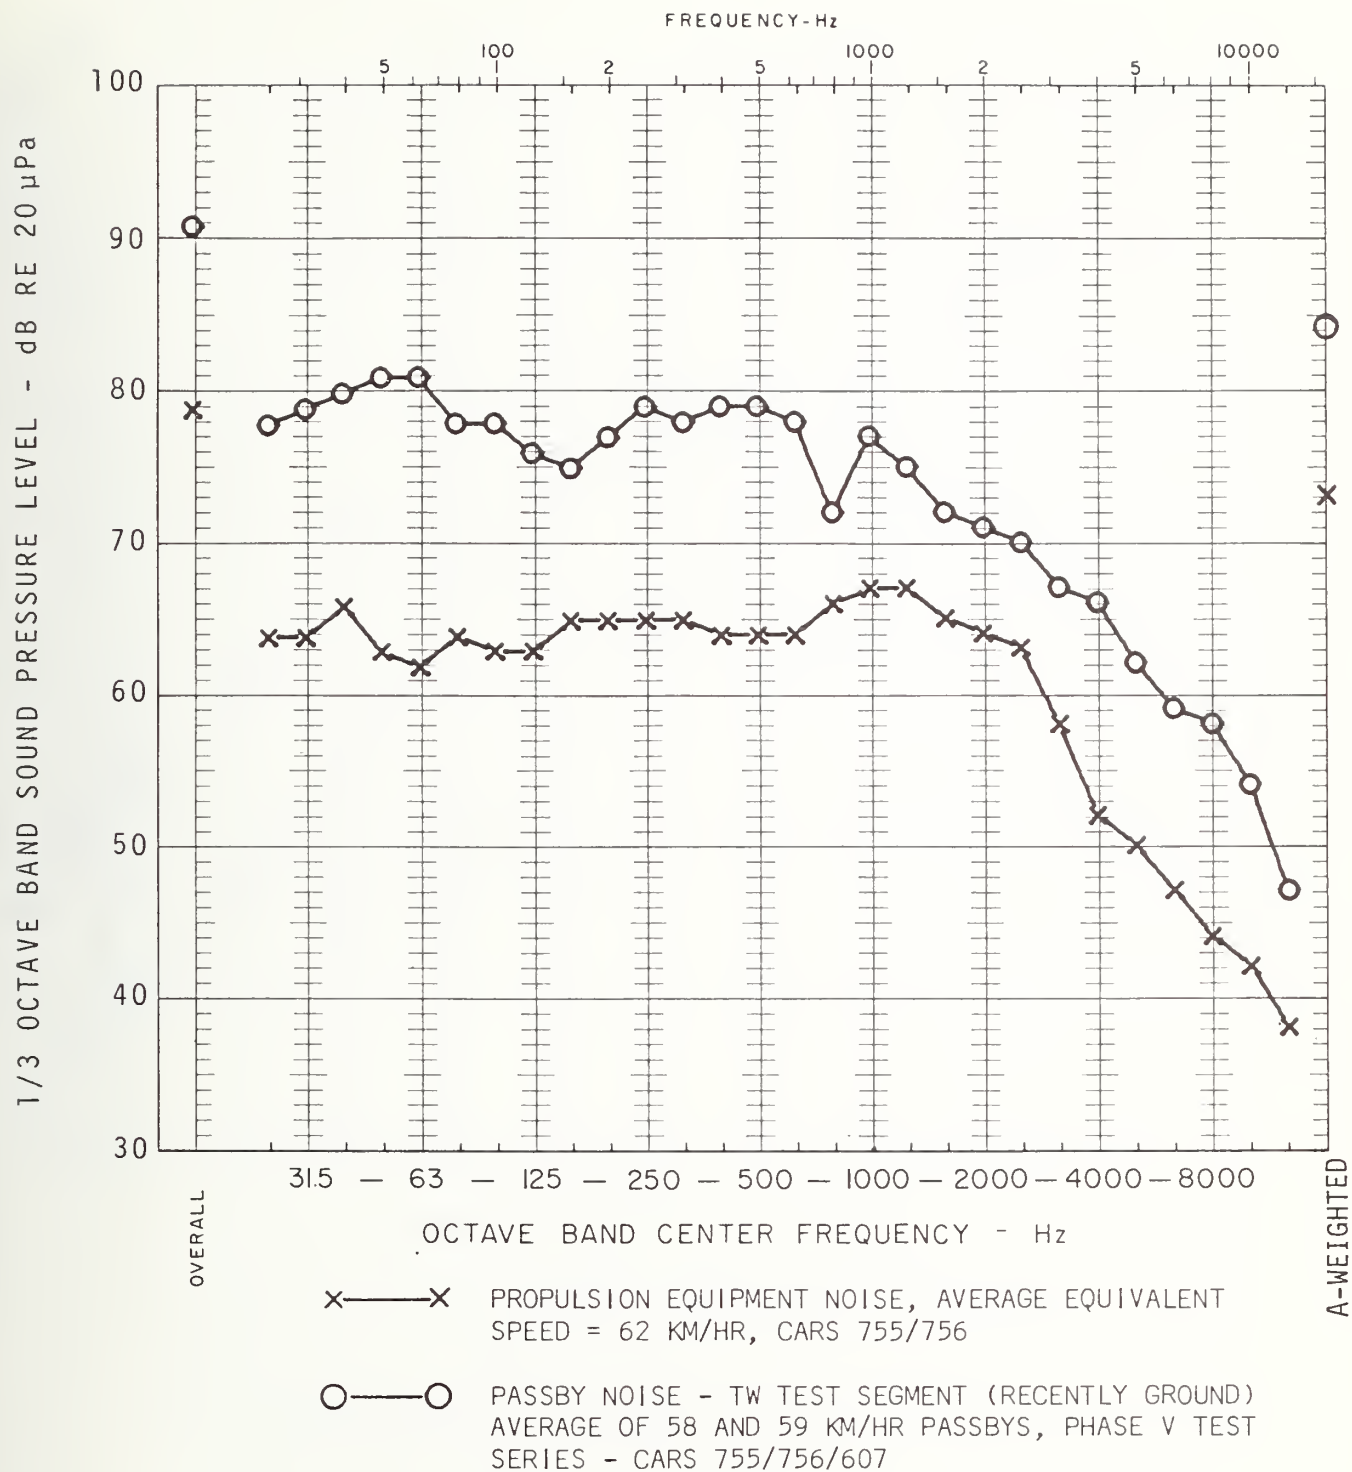
FIGURE 3-5. COMPARISON OF SPECTRA OF PROPULSION EQUIPMENT AND PASSBY NOISE - 7.5 M FROM TRACK CENTERLINE

Figure 3-5 compares the overall wayside noise and propulsion equipment noise for Cars 755/756, the married pair set of cars. The spectra for both the wayside noise and the propulsion equipment noise have shapes very similar to those for the single cars - Figure 3-4. The primary difference is that above 125 Hz the propulsion equipment noise spectrum for the married pair cars is 2 to 5 dB less than for the single cars. The spectrum for propulsion equipment noise shown in Figure 3-5 is the average of the data for Car 755 with an equivalent speed of 64 km/hr (taken in July 1976) and that for Cars 755/756 with an equivalent speed of 58 km/hr (taken in December 1977).

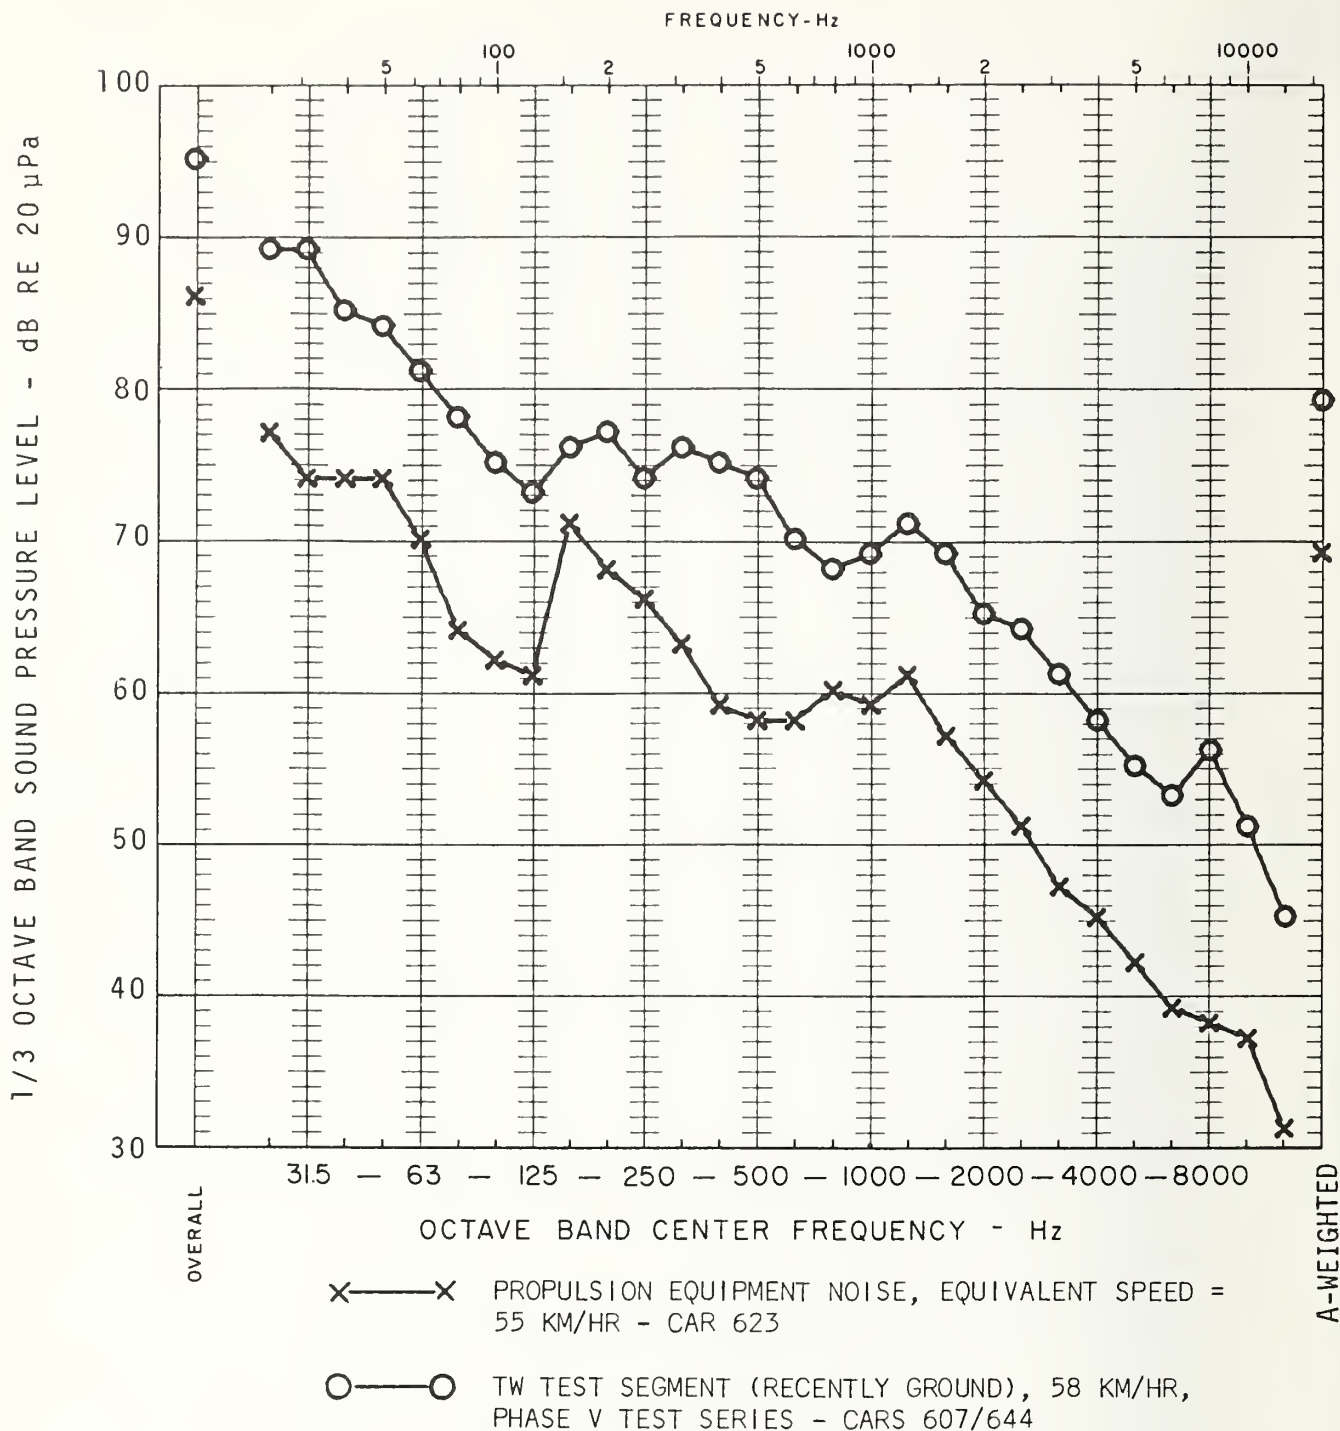
FIGURE 3-6. COMPARISON OF SPECTRA OF PROPULSION EQUIPMENT NOISE AND TYPICAL TEST EXAMPLE - CAR INTERIOR

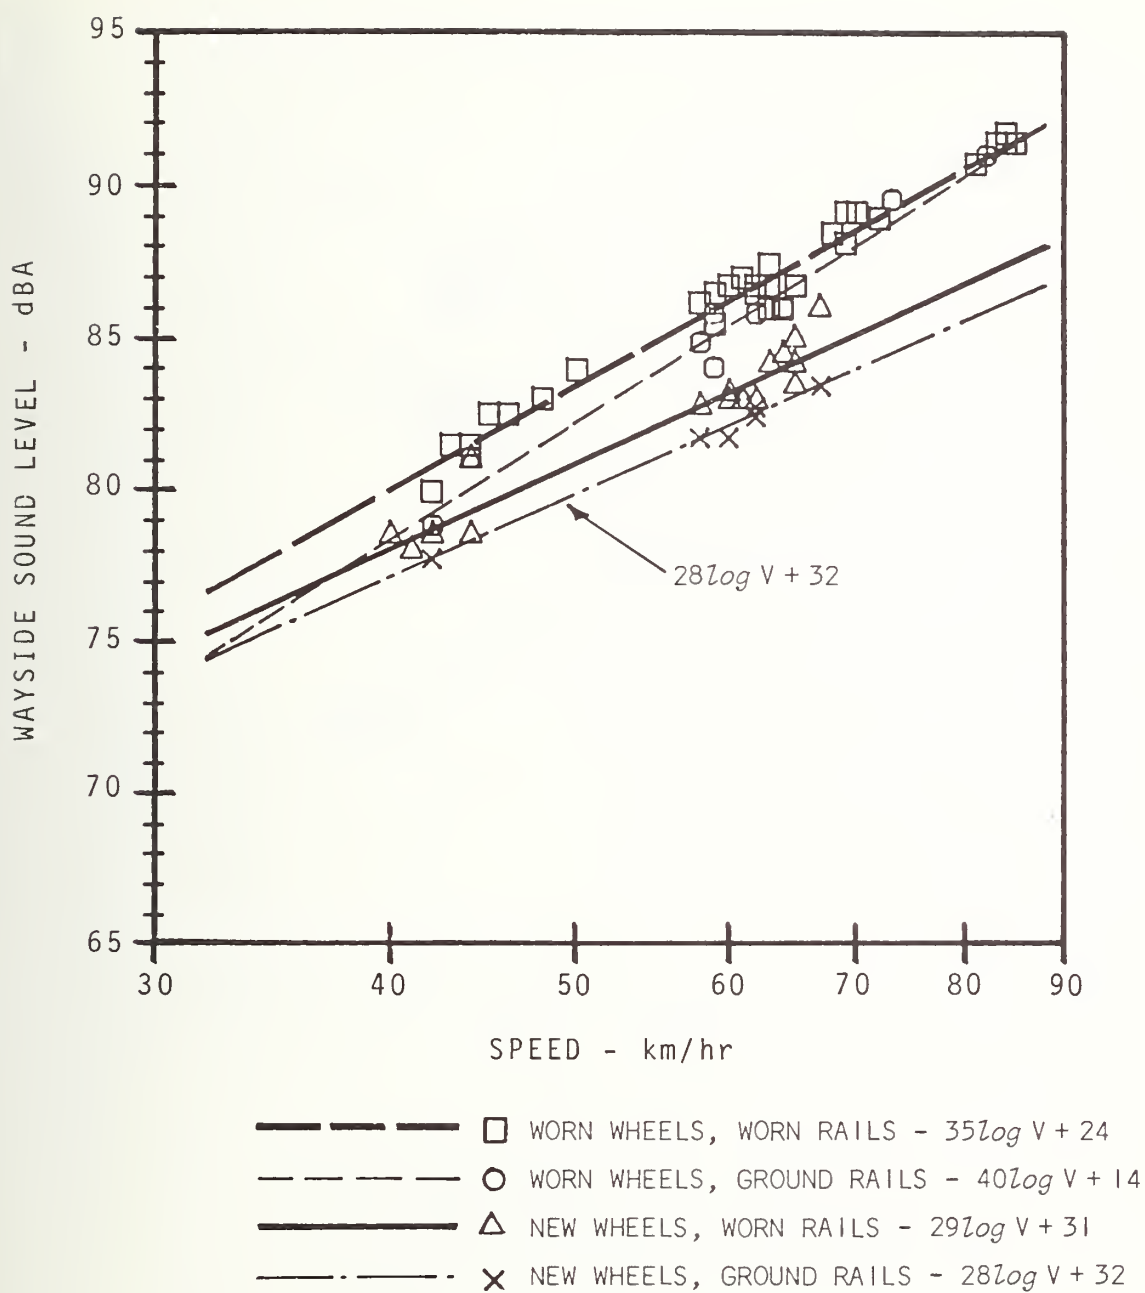
FIGURE 4-1. WAYSIDE SOUND LEVELS AT TW TEST TRACK WITH NEW AND WORN WHEELS AND WITH WORN AND GROUND RAIL  
TEST SERIES 2 - 7.5 m FROM TRACK CENTERLINE

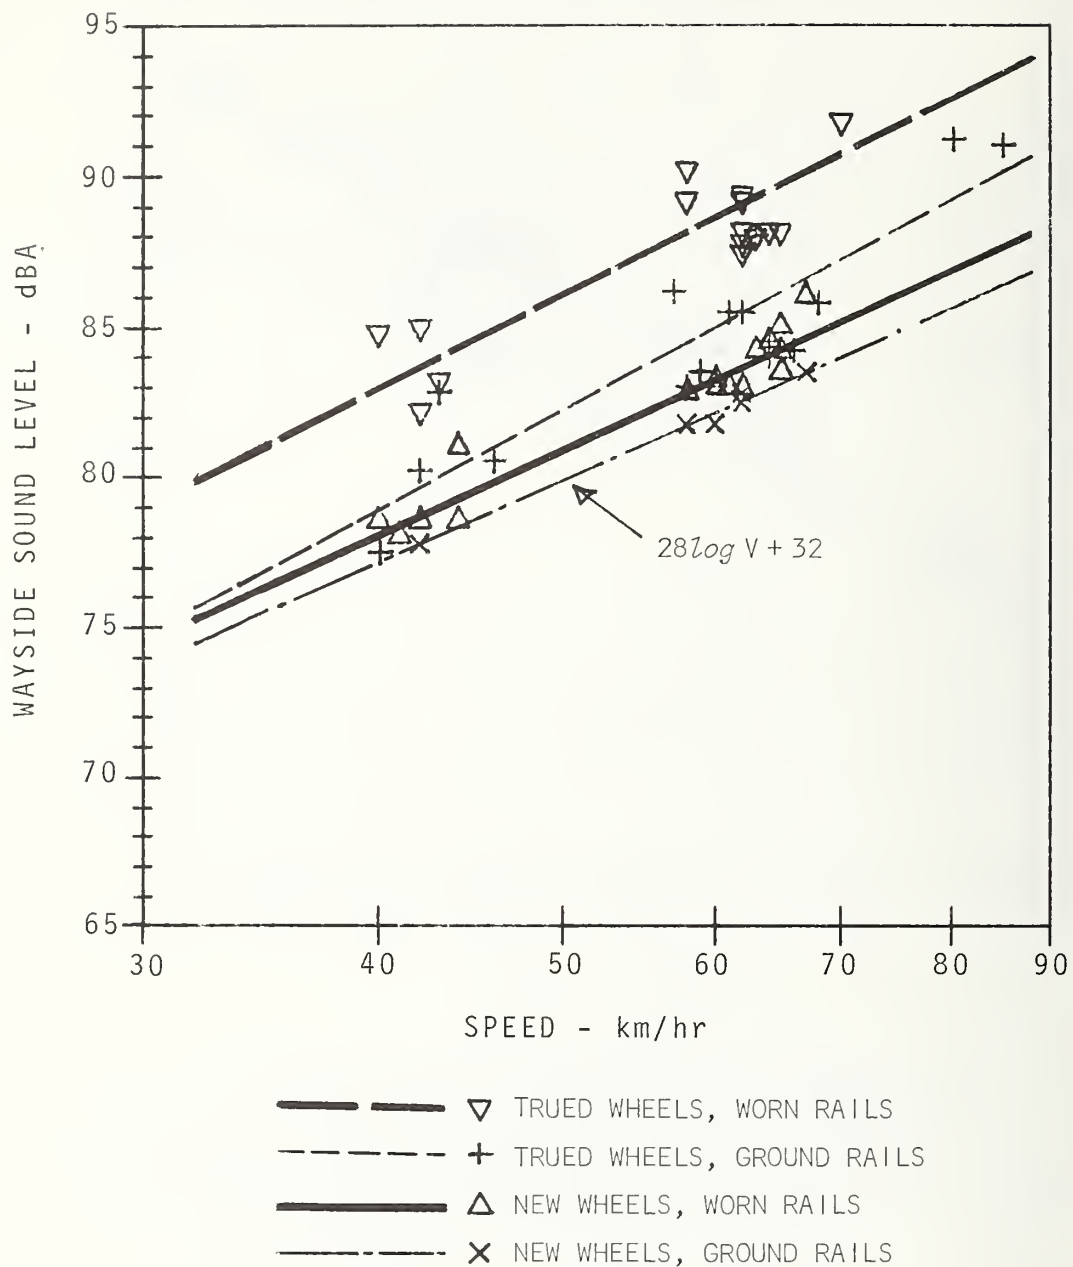
FIGURE 4-2. WAYSIDE SOUND LEVELS AT TW TEST TRACK WITH NEW AND TRUED WHEELS AND WITH WORN AND GROUND RAILS  
7.5 m FROM TRACK CENTERLINE

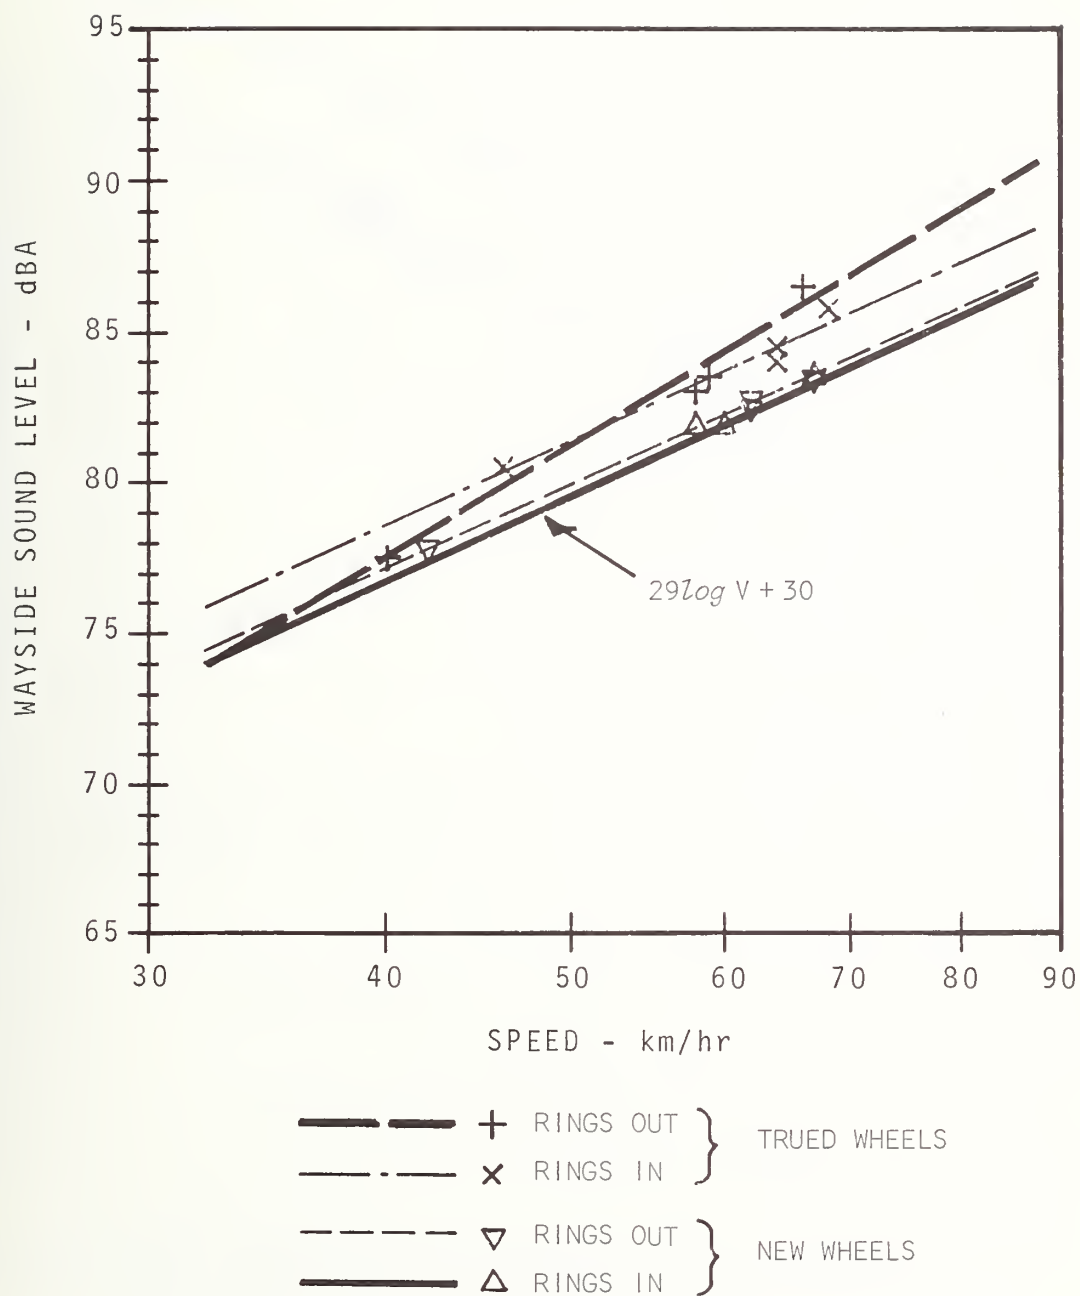
FIGURE 4-3. WAYSIDE SOUND LEVELS WITH AND WITHOUT RING  
RING DAMPERS, GROUND TANGENT WELDED TRACK,  
NEW AND TRUED GROOVED WHEELS

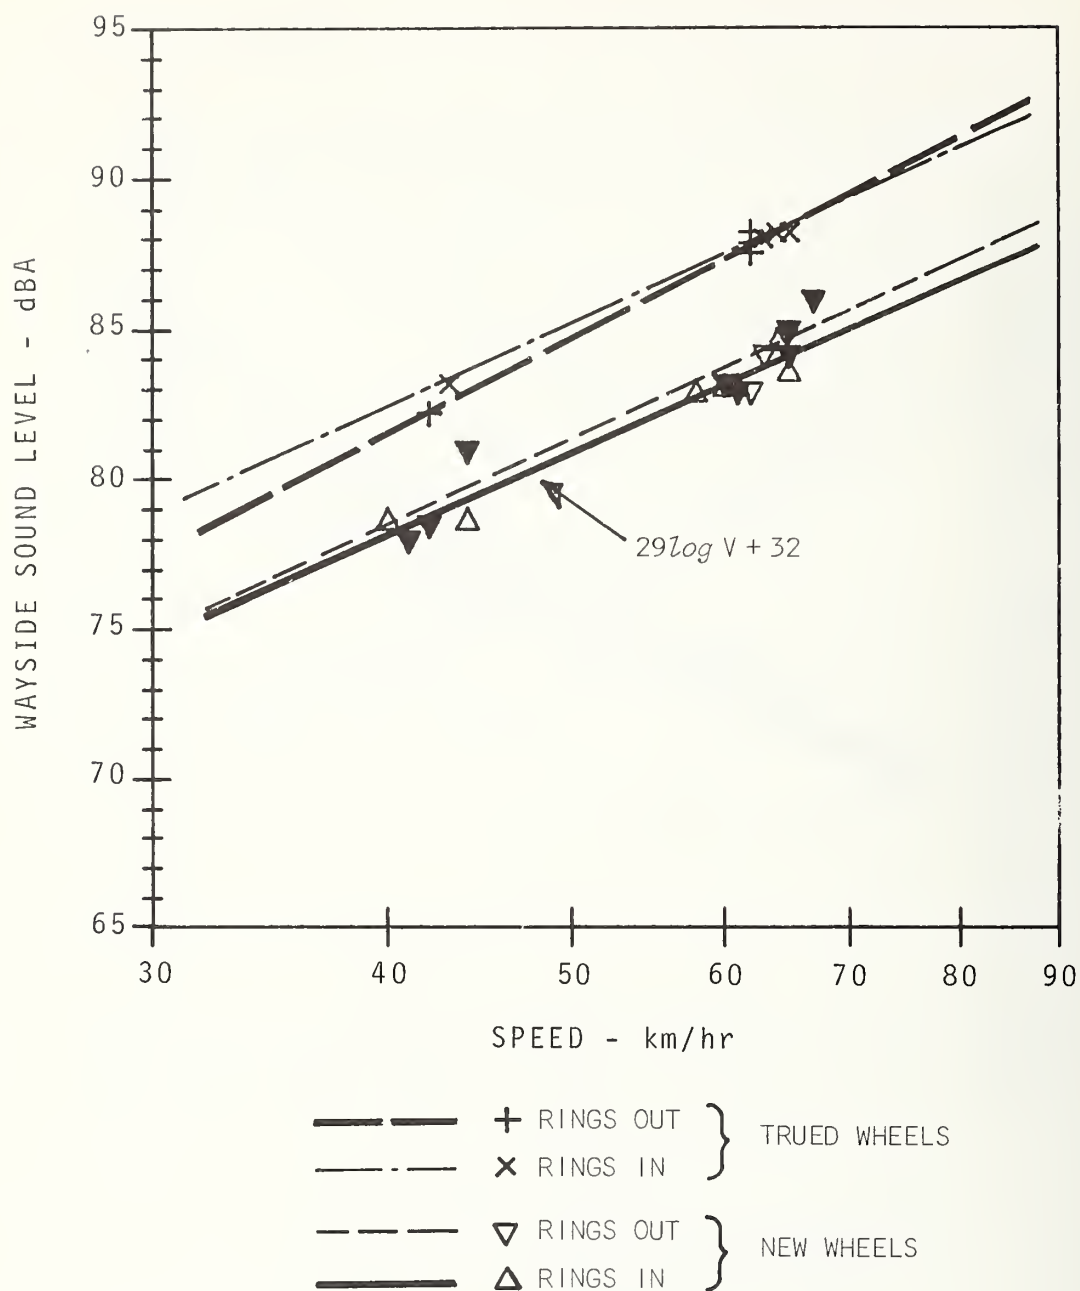
FIGURE 4-4. WAYSIDE SOUND LEVELS WITH AND WITHOUT RING DAMPERS, WORN TANGENT WELDED TRACK, NEW AND TRUED GROOVED WHEELS

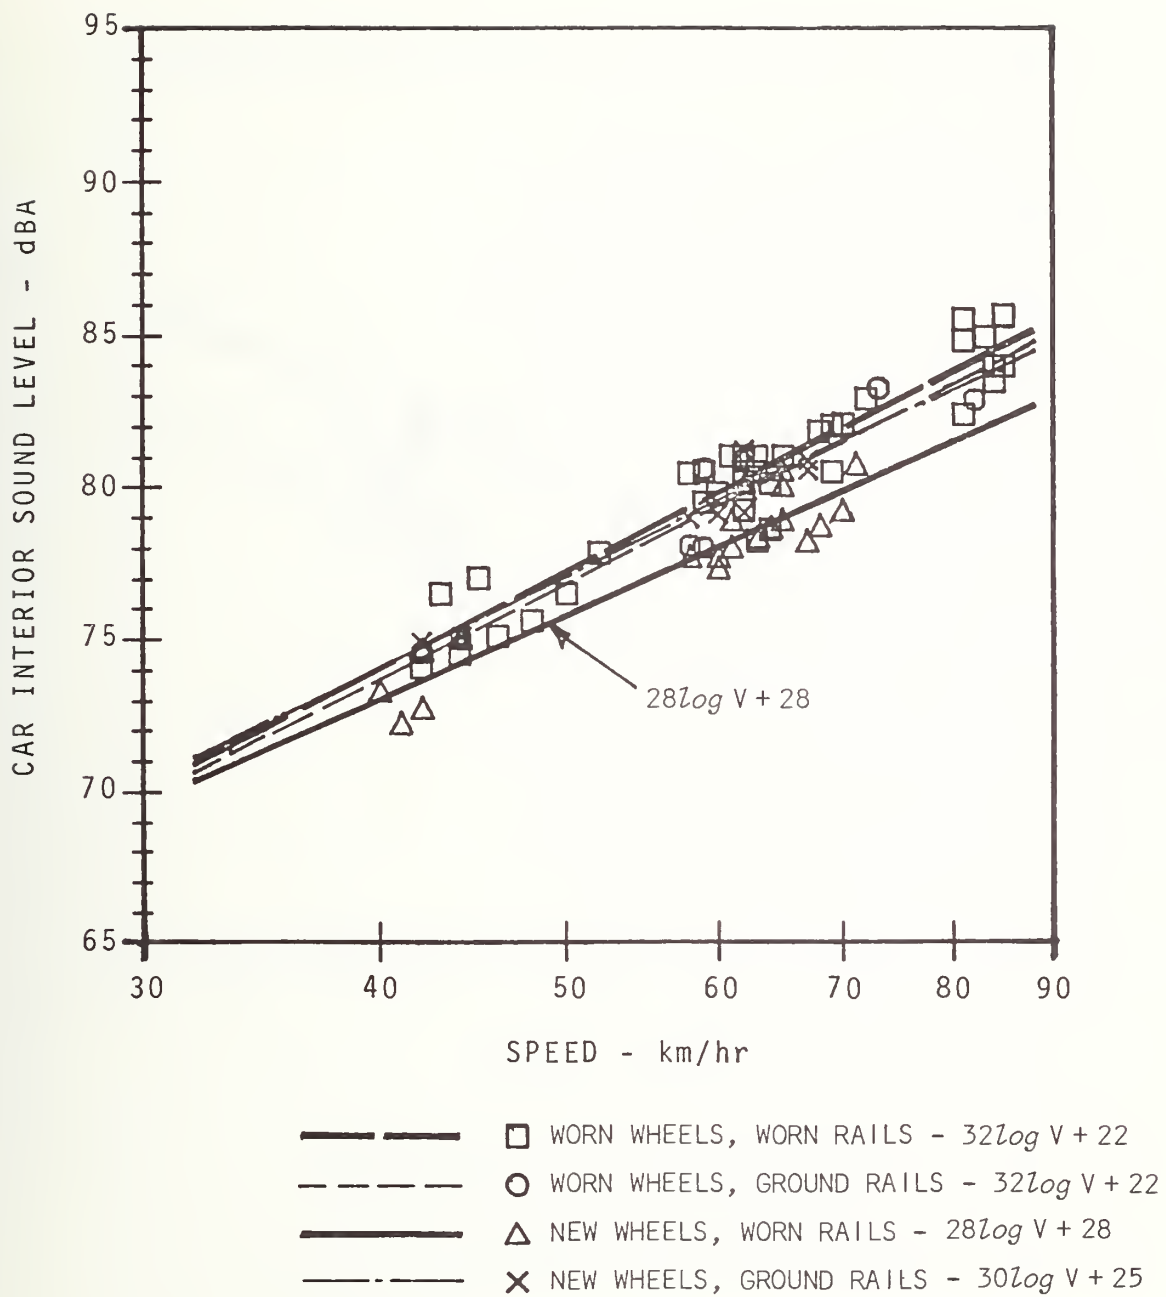
FIGURE 4-5. CAR INTERIOR SOUND LEVELS ON TW TEST TRACK WITH NEW AND WORN WHEELS AND WITH WORN AND GROUND RAILS - TEST SERIES 2

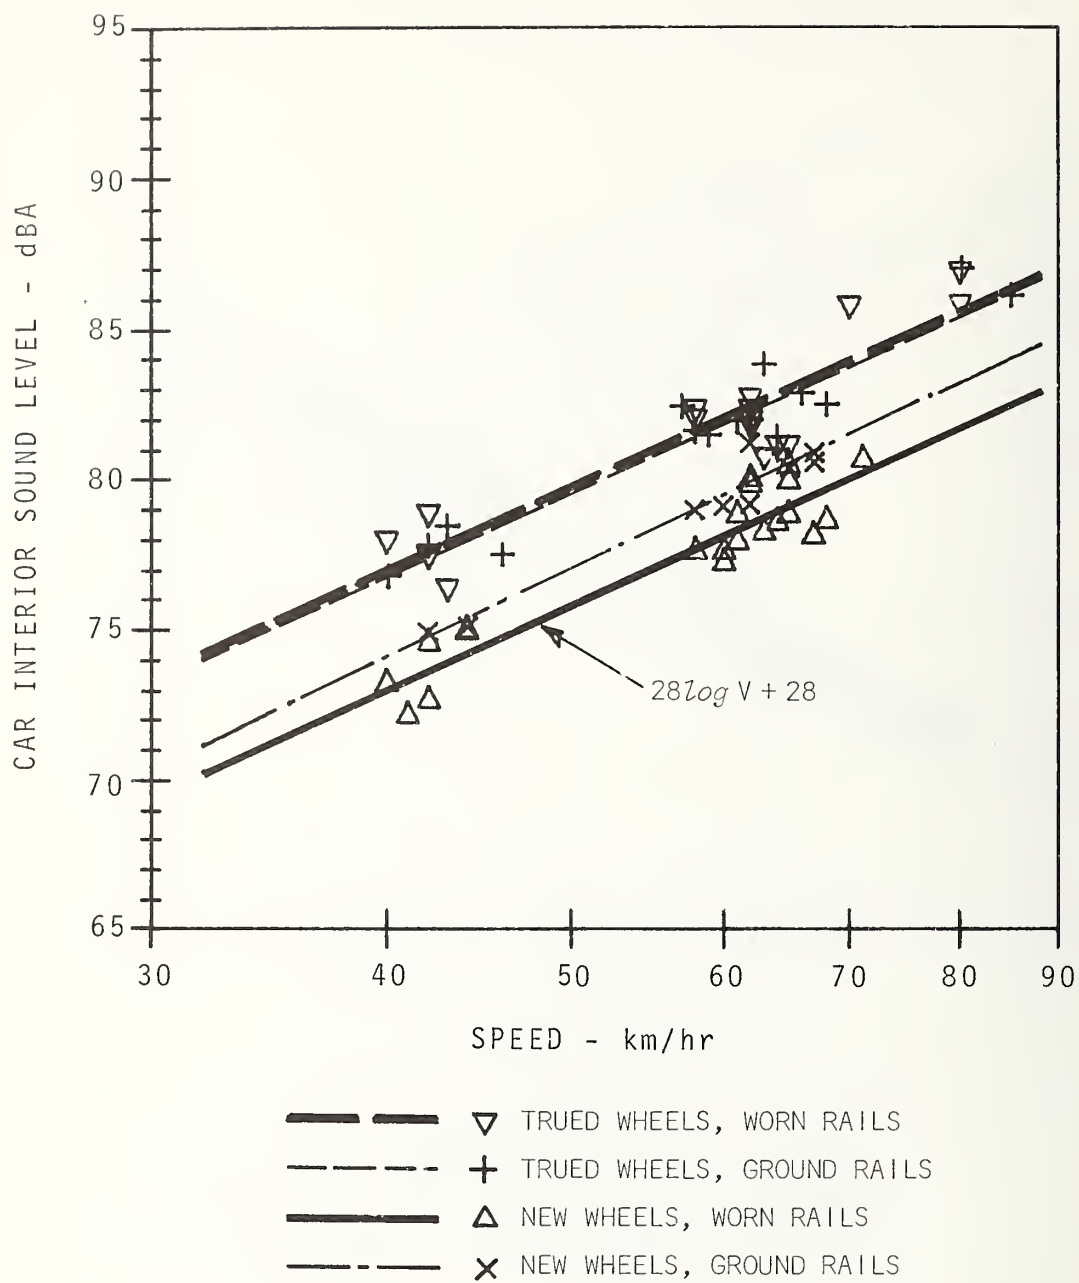
FIGURE 4-6. CAR INTERIOR SOUND LEVELS ON TW TEST TRACK WITH NEW AND TRUED WHEELS WITH WORN AND GROUND RAILS
